# Manhole Inspection Summary

Manhole # S49M\_\_014MH

Insp Date: **5/7/09 8:20 AM**

**Location** Address: **837 S MONTFORD-PORT-ALLEY** Cross Street: **ALLEY-FAIT-HUDSON**

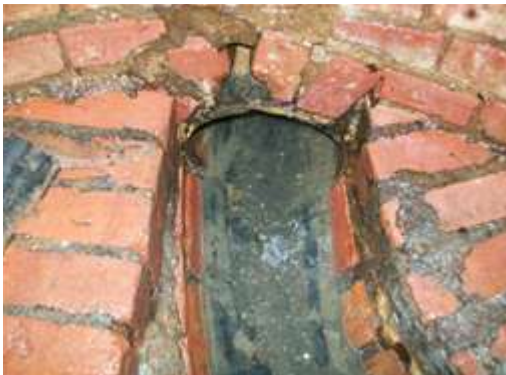
Defect 3

**Barrel** Material: **Brick** ☐ Parged

Condition: ☐ Sound ☐ Cracked ☐ Root Intrusion ☐ Loose Brick ☒ **Deteriorated**

DETERIORATED BARREL BRICKS

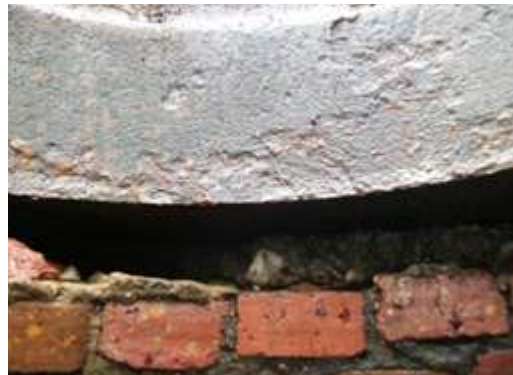
Defect 2

**Chimney / Frame Adjustment** ☒ Exists Material: **Brick and Concrete** ☐ Parged Height: **3** (in.)

Condition: ☐ Sound ☐ Cracked ☐ Root Intrusion ☐ Loose Brick ☒ **Deteriorated**

DETERIORATED CHIMNEY

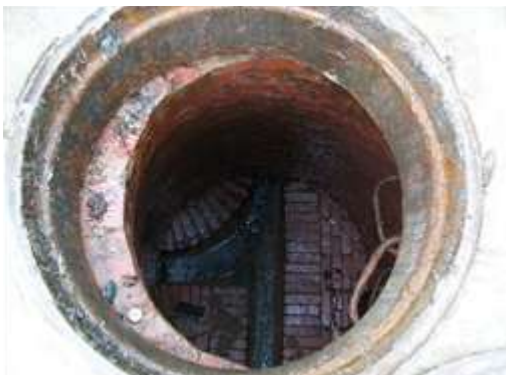
Defect 1

**Frame** Offset: **3** (in.) Condition: ☒ Sound ☐ Cracked ☐ Leaks

FRAME OFFSET

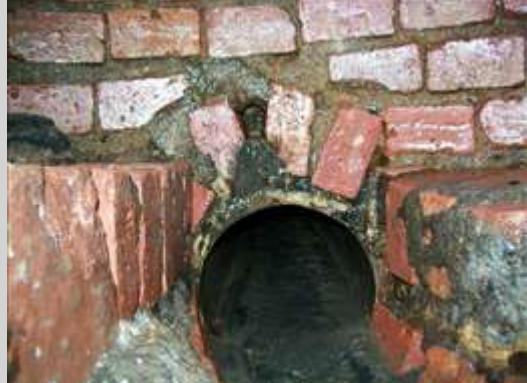
9 O'Clock Inflow

8 in. Circular Gravity Sewer

Pipe In @ 9 O'Clock

Infiltration: **Weeper** Pipe Seal Cond: **Cracked**
